Manhole Inspection Summary

Manhole # S71G__010MH

Location Address: **Conley St**

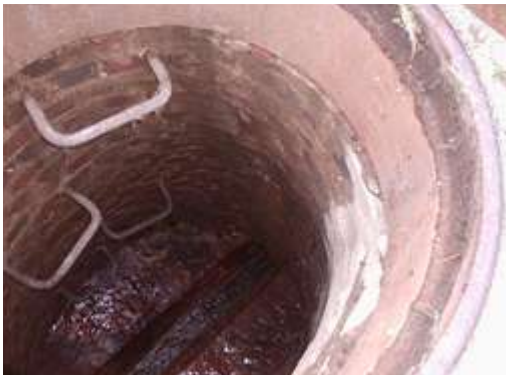
Defect 2

Offset: **1** (in.)

☒ **Leaks**

Frame leaks

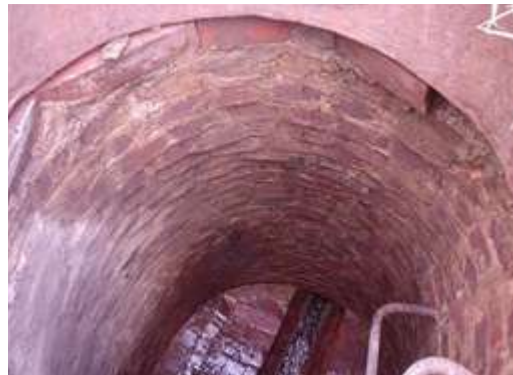
Defect 1

Condition: ☐ Sound ☐ Cracked ☐ Root Intrusion ☒ **Loose Brick** ☐ Deteriorated

Infiltration: ☐ None ☐ Joint ☐ Cracks ☒ **Mortar** ☐ Roots ☐ Wall

Loose brick

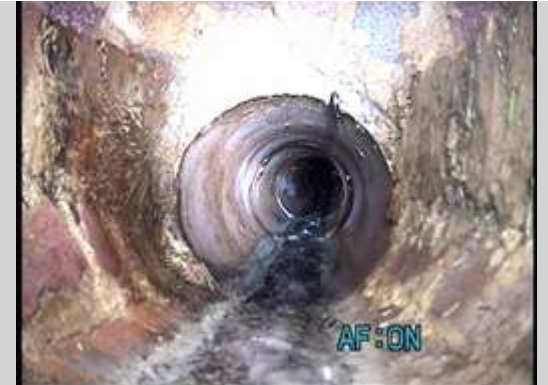
12 O'Clock Outflow

8 in. Circular Gravity Sewer
Pipe Out @ 12 O'Clock

Pipe Height: **8.4** (in.) Rod and Bar (Angled)
Pipe Material: **Clay** ☐ Pipe Lined
Invert Depth: **8.25** (ft.) Flow Characteristics: **Fast**
Deposits: ☒ None ☐ Mud ☐ Sludge ☐ Debris ☐ Grease
Silt Depth: (in.) Deposits Extent:
Infiltration: **None** Pipe Seal Cond: **Sound**

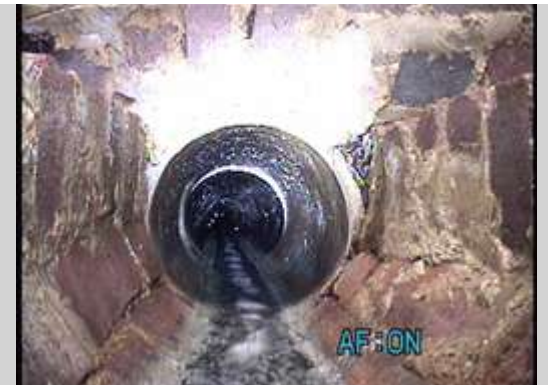
6 O'Clock Inflow

8 in. Circular Gravity Sewer
Pipe In @ 6 O'Clock

Pipe Height: **8.4** (in.) Rod and Bar (Angled)
Pipe Material: **Clay** ☐ Pipe Lined
Invert Depth: **7.90** (ft.) Flow Characteristics: **Fast**
Deposits: ☒ None ☐ Mud ☐ Sludge ☐ Debris ☐ Grease
Silt Depth: (in.) Deposits Extent:
Infiltration: **None** Pipe Seal Cond: **Sound**
